Fortieth Omnibus Objection to Claims (No Liability/Passthrough Claims)

FILE: Bankruptcy Case No. 19-30088 (DM), Claim No. 3524

SUBJECT: Response to Omnibus Objection

This memorandum provides details of the work performed by PG&E, the problems that ensued as a result of that work, and a history of the property and rainfall occurrences that support my claim that PG&E is responsible for the damage caused by incorrect grading and sloping of the pipeline easement at 163 Via La Cumbre, Greenbrae, California.

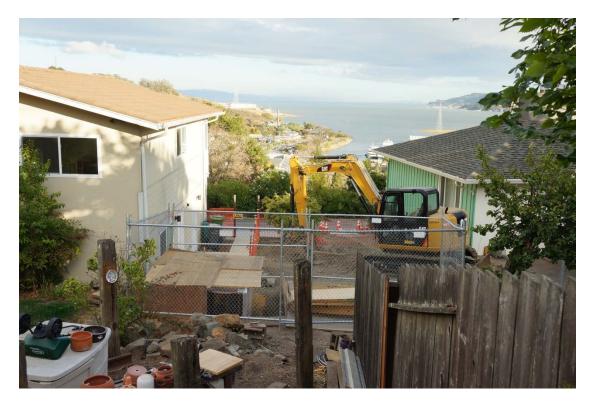
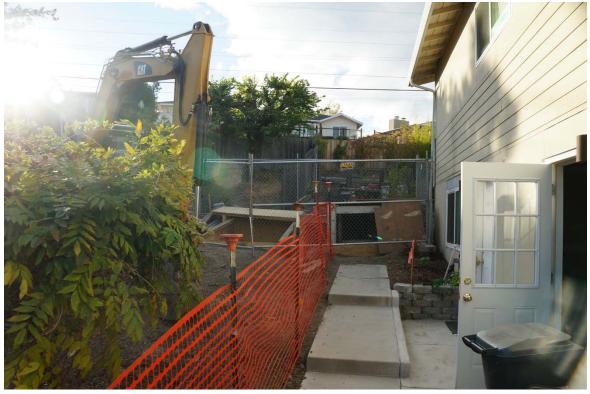
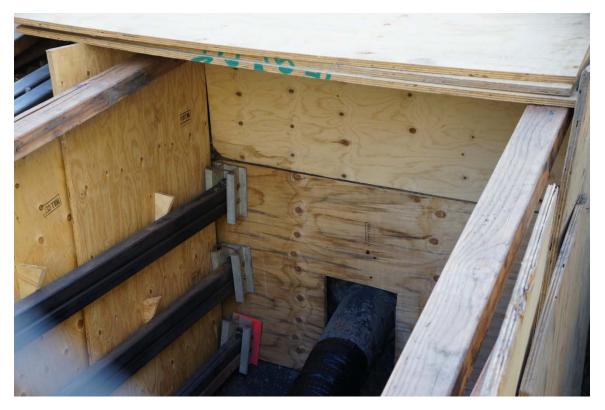
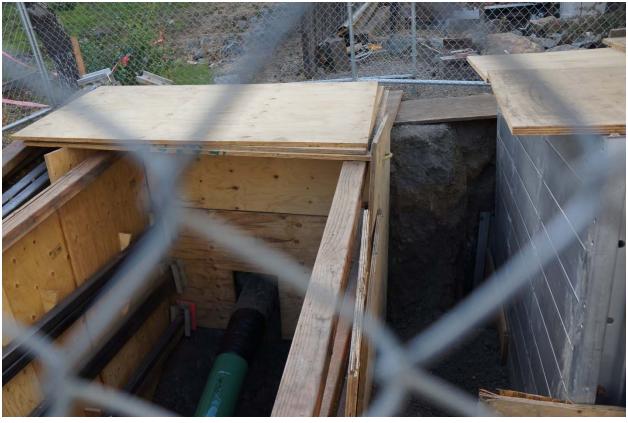
## **Exhibit A**

There is a 10-foot gas transmission easement that runs parallel to my house. In August 2014 excavation work began to hydrotest these high-pressure steel gas transmission pipelines. Over a period of 4-months work crews excavated two large craters that measured approximately 15x15 ft wide and 15 feet deep and required retaining walls. See Exhibit A. The scope of work changed drastically when they sent a scanning tool through the line and found a "huge gash in the line that needed to be addressed for pipeline safety." See Exbhibit B. Ultimately a third crater was dug in the front of the house to repair and resolder a final section of the pipeline. Eventually the work concluded, and the excavation holes were backfilled but not to the initial levels.

In the months that followed there was little rain and California continued to experience Its longest duration of drought<sup>i</sup> which ended March 2019. Since there was little to no rain over this span of time the problem that eventually arose, from the negative grading and slope towards the house, was not apparent. Ultimately it was two atmospheric rivers<sup>ii</sup> in January and February 2019<sup>iii</sup> that caused significant runoff to flood the garage and basement. See Exhibit C. My family has owned and occupied this house since 1958 and up until this point in time there has never been negative drainage or flooding. To provide perspective, occurrences of historic flooding of equal or larger sizes in 1982-1983<sup>iv</sup>, and 1986<sup>v</sup> never caused runoff issues or flooding at the house. A closer observation of the backfill work done by PG&E shows negative grading and sloping towards the house. There are also visible dips in the soil which indicate compaction concerns. Backfilling trenches containing utility lines involves special techniques and considerations. An engineer was consulted, and their recommendation was for additional backfill and compacting in layers to raise easement to original level and grade to direct water away from the house. Consider addition of swale or French drain that ties into existing drainage system.

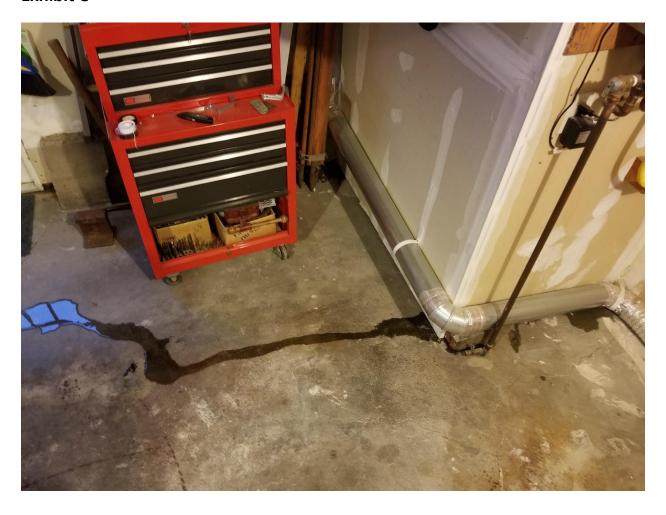
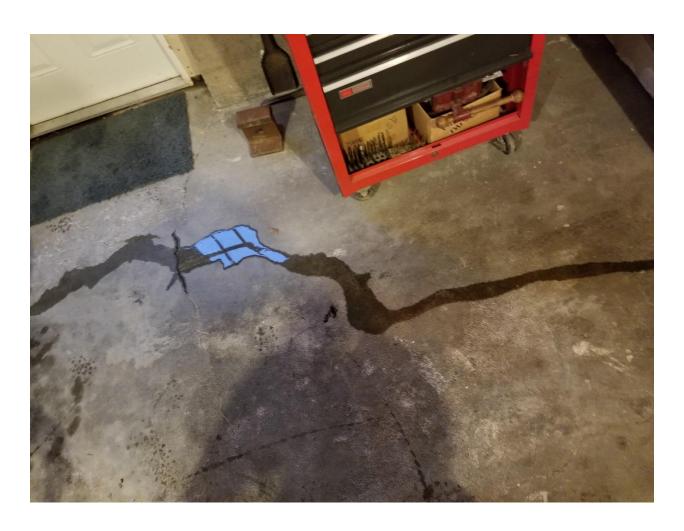
## **Exhibit C**

For 56 years, flooding in my garage and basement from hillside runoff did not occur. Flooding began after the 2014 excavation work done by PG&E, therefore PG&E is responsible for the flooding that has occurred since then and is responsible for the costs to regrade the easement. In addition to the Exhibits that are provided I can provide an eyewitness to the flooding that occurred.
